5/039/0035

unpermitted landscape rock mine (S/039/0035) - photos of existing excavation

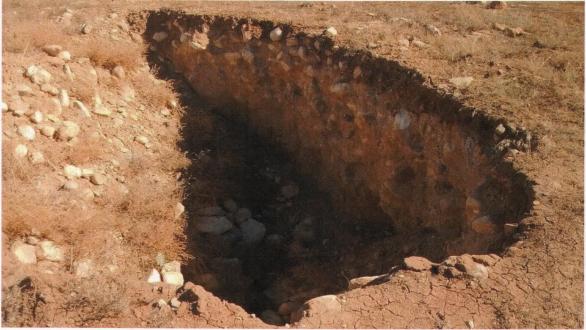
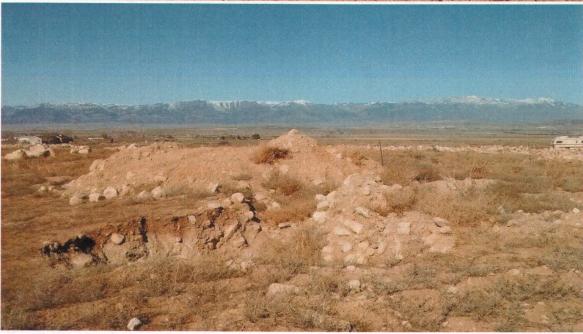
Thanks for the call yesterday. Here are a few photos of the existing hole and dirt piles at your unpermitted landscape rock site north of Spring City. The area of existing disturbance (including overburden) covers an area of about 40' x 20' total. This excavation is on the east end of the mined area. It's not a big disturbance, but we can't release your regrading liability until it's backfilled.

Let me know if you have questions, and I'd appreciate hearing when the hole has been backfilled. Thanks.

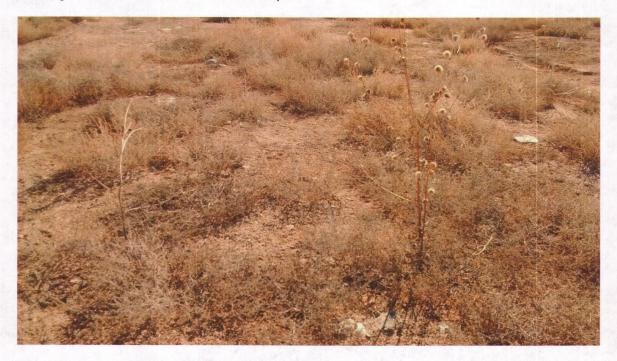
After last year's sunflowers, beneficial revegetation has not yet come in on the previously backfilled and graded areas (as of the middle of March - I will check again). These areas were seeded in February 2015. A number of weedy species dominated the area last year, but these are usually temporary while rangeland-type grass and other species establish over 2-5 years. There are noxious weeds in the neighborhood, but I haven't seen any at this specific site. Cheatgrass is in adjacent fields.

Sometimes seeding fails. If that's the case, we'll recommend re-seeding either this or next late fall. Drill seeding is often most effective for most species.
